State of Nevada  
Department of Health & Human Services  
Division of Public and Behavioral Health  
Rawson-Neal Psychiatric Hospital  
Facility Condition Analysis

# RAWSON-NEAL PSYCHIATRIC HOSPITAL

**Site Number: 9894**  
**STATE OF NEVADA PUBLIC WORKS DIVISION**  
**FACILITY CONDITION ANALYSIS**

Report Printed in August 2015

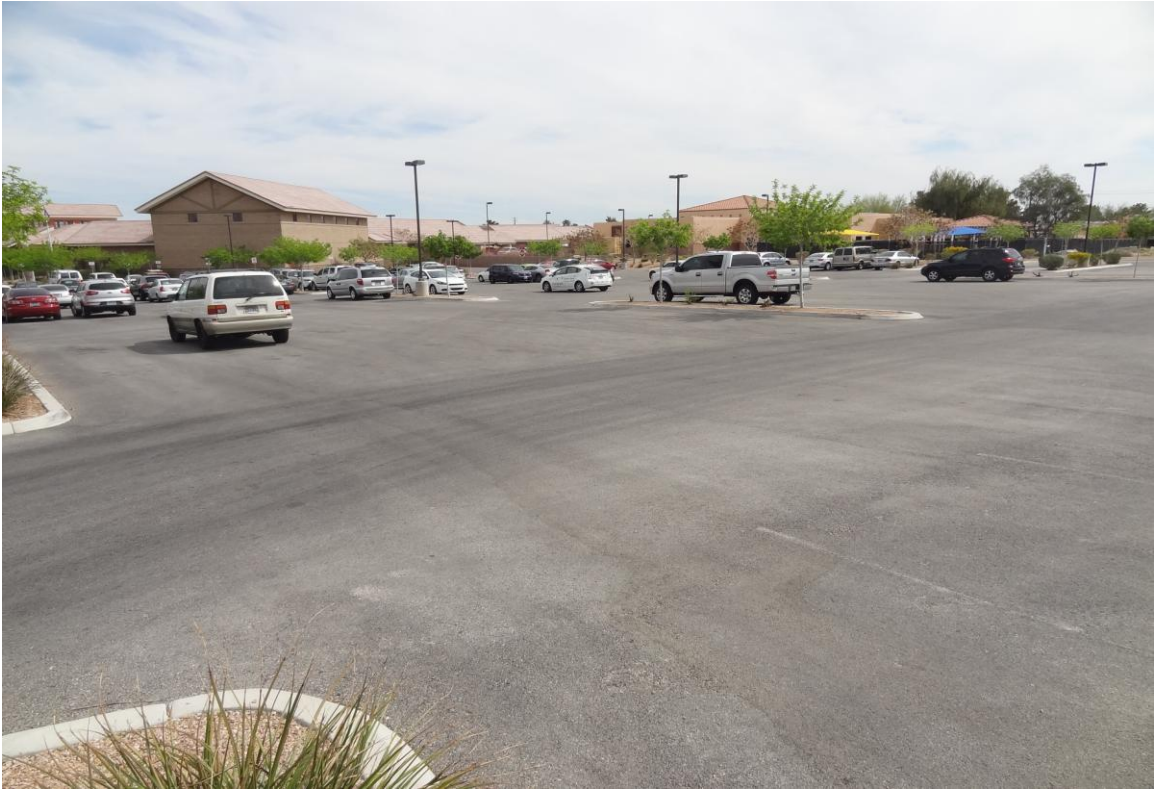
Rawson-Neal Psychiatric Hospital Site – FCA Site #9894

Description: View of the AC paved parking area.

It is important to maintain the asphalt concrete paving on the site. This project would provide for minor crack filling and sealing of the paving site wide including access roads and parking areas. Striping is included in this estimate. This project should be scheduled on a 5 year cyclical basis to maintain the integrity of the paving and prevent premature failure. 164,000 square feet of asphalt area was used to generate this estimate.

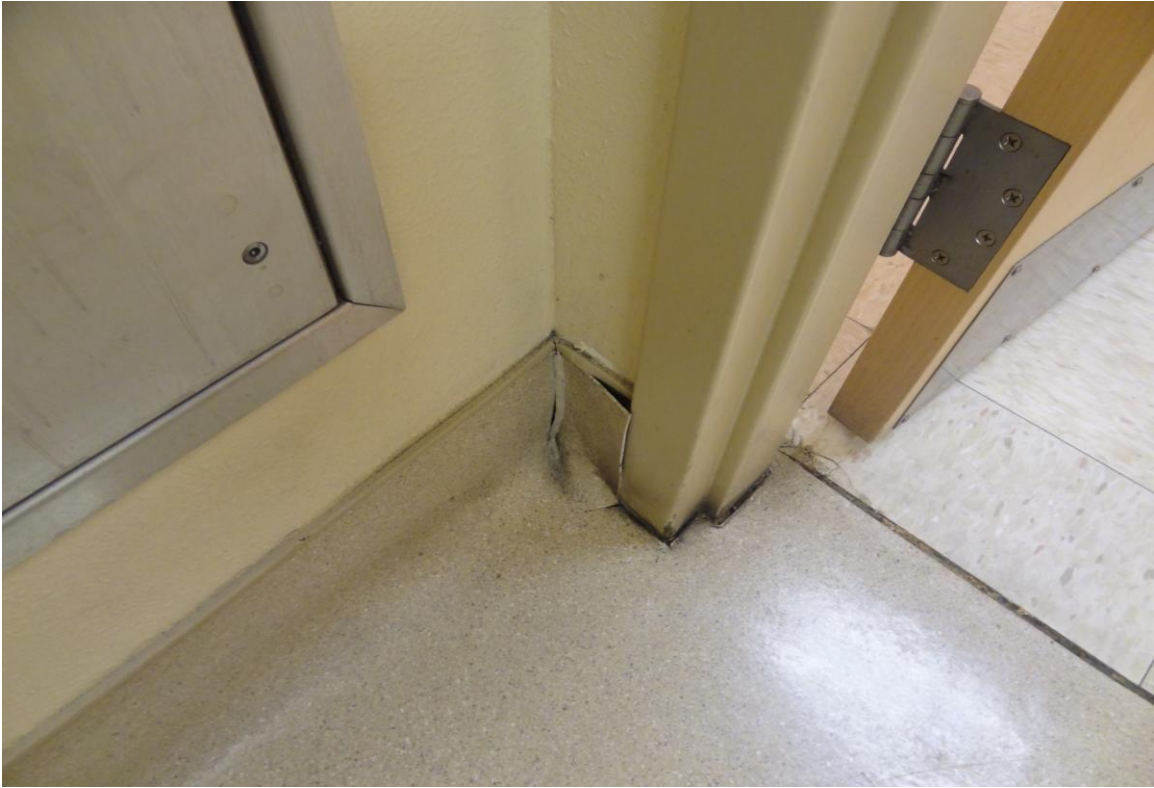
Rawson-Neal Psychiatric Hospital – FCA Building #2508 and #2510  
Description: Damaged sheet vinyl at restroom.

The 12 restrooms in the client living areas are original to the building and in overall poor condition. The finishes, fixtures, cabinets, toilets, showers and exhaust fans are showing signs of wear and deterioration. The original ceramic water closets pose a safety hazard and should be replaced with stainless steel fixtures. There is also a need for anti-ligature fixtures including the faucets. This project would provide for a complete remodel of the restrooms. The removal and disposal of the existing fixtures and finishes is included in this estimate.

The 7 restrooms in the client living areas are original to the building and in overall poor condition. The finishes, fixtures, cabinets, toilets, showers and exhaust fans are showing signs of wear and deterioration. The original ceramic water closets pose a safety hazard and should be replaced with stainless steel fixtures. There is also a need for anti-ligature fixtures including the faucets. This project would provide for a complete remodel of the restrooms. The removal and disposal of the existing fixtures and finishes is included in this estimate.
